Plate 1 - Suntrap - stormwater pipe causing local erosion of bank.JPG

Plate 2 - Suntrap - Second stormwater pipe causing local erosion of bank.JPG

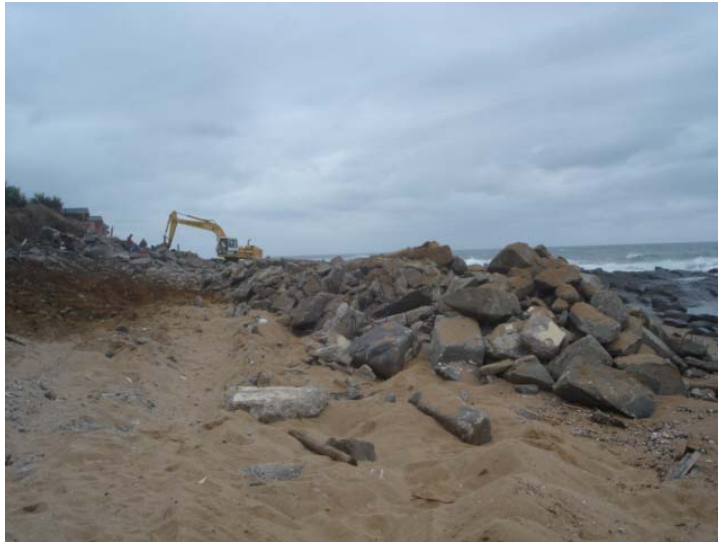
Plate 5 - Suntrap - Local Authority clearing debris for repair of pipe line.JPG
